**RESULTS FROM CAVITATION DAMAGE EXPERIMENTS WITH
MERCURY SPALLATION TARGETS AT THE LANSCE – WNR IN 2008**

B. W. RIEMER

ICANS XIX,
19th meeting on Collaboration of Advanced Neutron Sources
March 8 – 12, 2010
Grindelwald, Switzerland

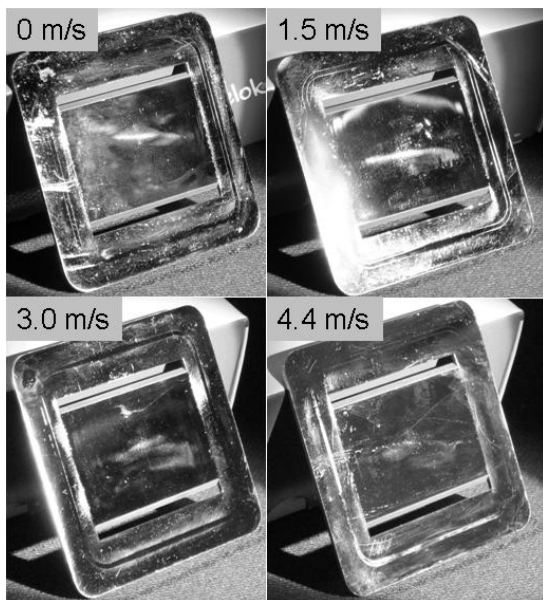
Photographs of the front channel (beam entrance) inside surface are shown in Fig. 4 for each test velocity. The photos do not completely capture all locations of damage but were helpful for general impressions and for identifying locations to examine with the laser microscope. A horizontally oriented elliptic cluster of damage pits is apparent on all of these surfaces. The cluster appears to lessen in pit density with increasing flow. Smaller clusters of pits can be seen above and below the main group; it turns out that the deepest pits predominantly came from these smaller clusters.

Fig. 4 Photographs of WFVTL front channel inside surfaces at 4 channel velocities.

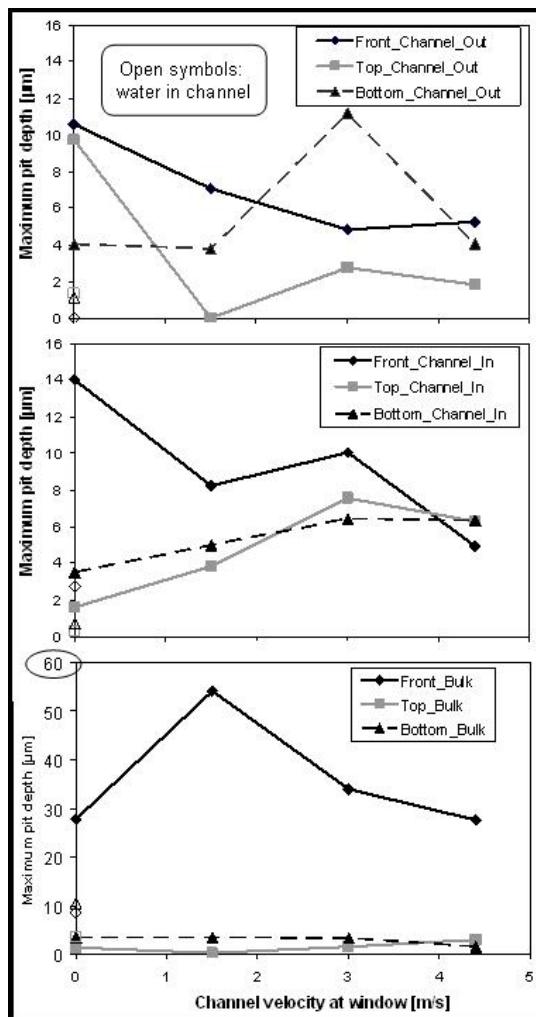
Fig. 6 shows the result of tallys for overall maximum pit depth for each surface. Note the change in scale for the bulk side surface due to the larger result from the front location.

Fig. 6 Overall maximum pit depths for each test surface vs. channel flow velocity.

Experiments investigating damage vulnerability of a mercury cooling channel feature of the SNS target resulted in the conclusion that the channel is not the most damage susceptible location, contrary to previous information. As a result a design change to the SNS target to eliminate this channel is not warranted.

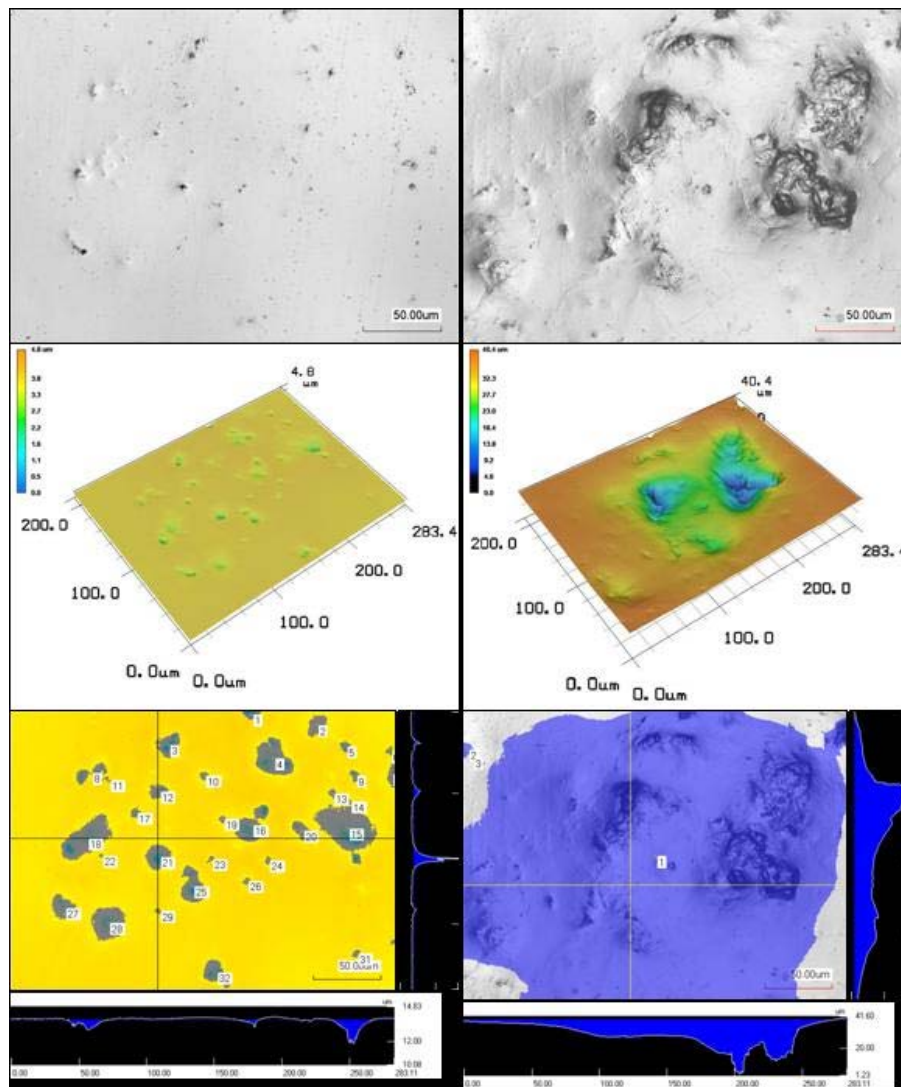
Example images and profile data from two surface locations are shown in Fig. 5. The example on the left hand side is typical of a modestly damage location with the deepest features being several μm deep. The pits have a range of equivalent diameters and there were more than 30 pits distinctly identified. The right side is one of the greatest damaged locations; nearly the entire region is identified as a single pit that is $40\ \mu\text{m}$ deep, even though it is apparent that multiple cavitation collapse events occurred on this region.

Fig. 5 Top to bottom: image, 3D profile and identified features with line profiles. Left side is bottom channel inside surface with 3.0 m/s velocity; right is front bulk side surfaces for 1.5 m/s.

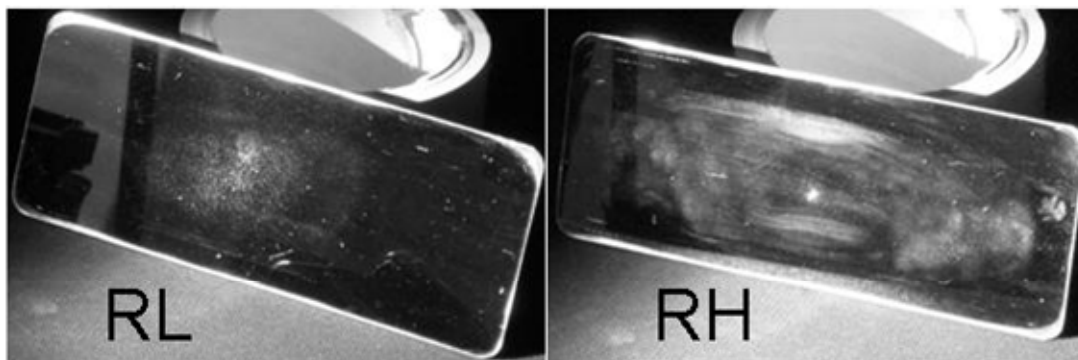
Fig. 7 Photographs of front plates from rectangular beam intensity test targets show damage on original mirror-like surfaces. Left is from low intensity beam (RL); Right is from high intensity beam (RH). Plate height and width are 64 x 165 mm.

Photographs of the front plates (beam entrance windows) of the low and high intensity test targets are shown in Fig. 7. The high intensity plate has a more focused spot surrounded by broad areas of cloudy regions. The low intensity plate spot is much less concentrated and cloudy regions are less apparent.

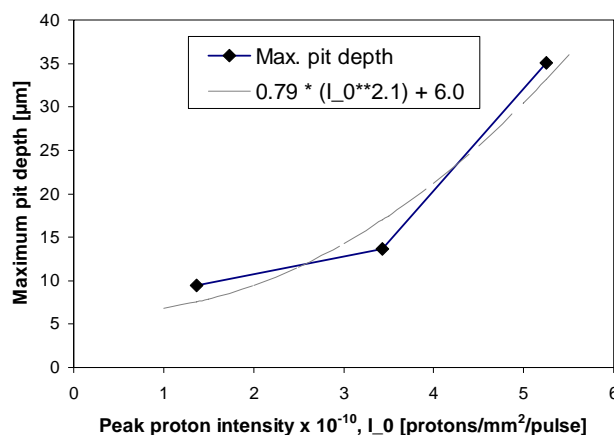
Overall maximum pit depth results for the three intensities are presented in Fig. 8 as a function of peak proton intensity per pulse (average results from 100 pulses each condition). Also shown is an attempted fit to the results; the power law dependency exponent is closer to 2 rather than 4.

Fig. 8 Overall maximum pit depth vs. peak beam intensity along with an attempted fit of the results.

Investigation of damage rate dependence on incident proton beam intensity has shown a weaker dependence than previously believed. The results are closer to a quadratic scaling. The conducted tests varied intensity by changing beam profile while maintaining charge per pulse, i.e., they maintained the total energy on target. The experiments did nothing to refute damage dependence on intensity when profile is fixed but charge per pulse is varied. That may still scale by a power law with exponent near 4.

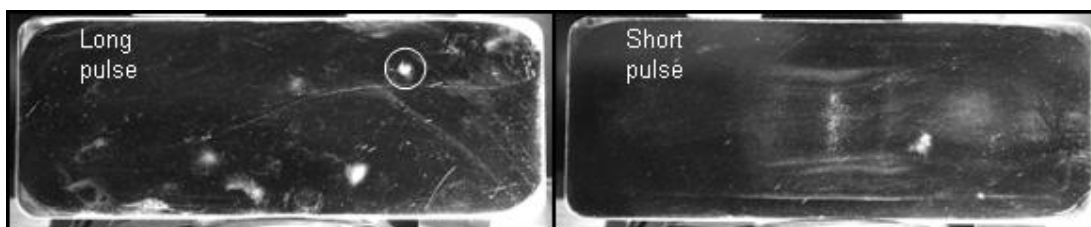
No clear evidence of cavitation damage could be found on the long pulse test plate. However there were some features that lack unequivocal explanation. Spots of cloudy regions can be seen on the long pulse surface shown on the left side of Fig. 9. Virtually all of the features are fractions of a μm deep and have pit morphologies unlike cavitation pits. The short pulse plate with the same profile is shown for comparison on the right. The central cluster of pits on the short pulse plate is not seen on the long pulse plate. There is a similar cloudy spot on the short pulse plate similar to those seen on the long pulse plate.

Fig. 9 Long pulse test surface on left; short pulse on right. The same beam profile was applied to both, but indications are that the long pulse had 70% greater proton fluence.

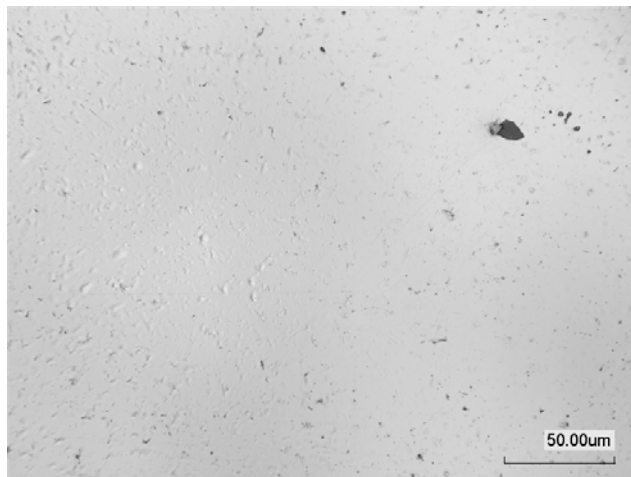
A microscope image from the circled region on the long pulse plate is shown in Fig. 10. The numerous small features are more faceted than typical cavitation pits and are most likely from improper polishing. The origin of large, dark feature in the upper right is not clear. Nearby small features are more typical of material defects.

Fig. 10 Laser microscope image from cloudy spot on the long pulse test surface.
