EXPERIENCE WITH IPNS TARGETS

J. M. Carpenter and A. G. Hins
Argonne National Laboratory

Abstract

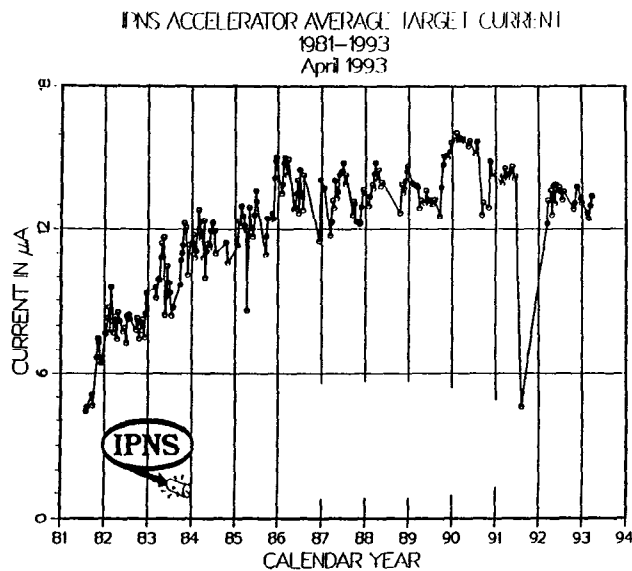
Figure 2 Weekly averaged proton current on the IPNS targets.

Figure 2 shows the average proton current on the IPNS target from turnon in May, 1981 until the present. IPNS ran about 26 weeks per year in the early years and 18 weeks per year in FY 1992, diminishing about linearly in between. For most of this time, the proton energy was 450 MeV. Through 1984, the Neutron Scattering Target received beam 75% of the time; the Radiation Effects Facility received the remaining 25%. The targets suffered between 10 and 100 full thermal cycles each day.

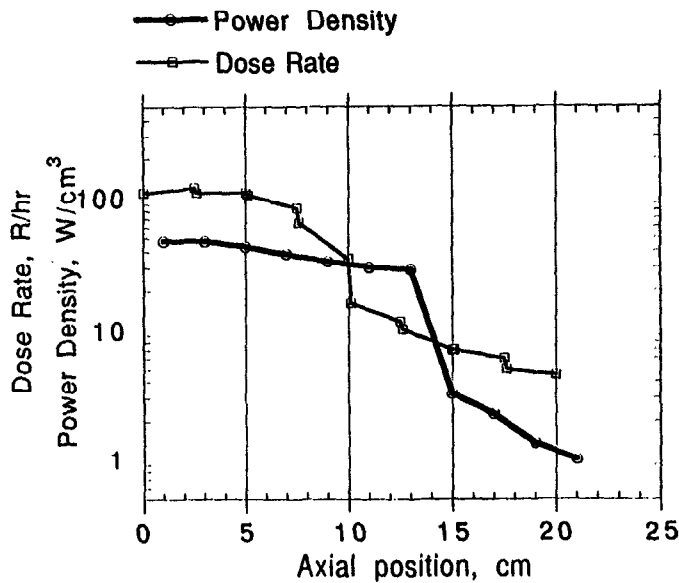
Figure 6 Gamma-ray dose rate as a function of disk position in the depleted Uranium target, and power density calculated for 500 MeV protons.

We removed the leaky depleted target into a hot cell for destructive examination. Sawing away the vessel, we were easily able to remove the target disks. We have completed a series of preliminary examinations and non-destructive tests. Figure 6 shows the gamma-ray dose rate measured 8 cm from the surfaces of the individual

disks, a measure of their activation by proton irradiation. As expected, the highest activity is confined to the front of the target. The figure also shows the power density calculated for 500 MeV protons. The fall-off at the end of range (13.4 cm of U metal, 11.4 cm for 450 MeV) occurs farther downstream than the fall-off in the measured dose rates; as of the time of writing, we do not understand this.
