**REMOTE HANDLING REPLACEMENT OF MERCURY TARGET AND  
PROTON BEAM WINDOW AT SNS**

After several years of operation, radiation-induced material degradation has necessitated replacement of the initially-installed mercury target and proton beam window modules at SNS. Due to the hazardous nature of these operations, replacement of both modules was performed entirely using remote handling methods. Replacement of the target module was carried out in a hot cell environment utilizing a combination of through-the-wall manipulators and a bridge-mounted servo-manipulator. Proton beam window replacement was accomplished in a high bay environment using casks and specially-designed long-handled tooling to mitigate personnel exposure. The details of these replacement operations will be discussed along with the specialized tooling developed to facilitate remote handling. Dose rates and contamination levels encountered during the replacement activities will be outlined. Lessons learned from the replacement operations will also be discussed.

**ICANS XIX,**  
**19th meeting on Collaboration of Advanced Neutron Sources**  
March 8 – 12, 2010  
Grindelwald, Switzerland

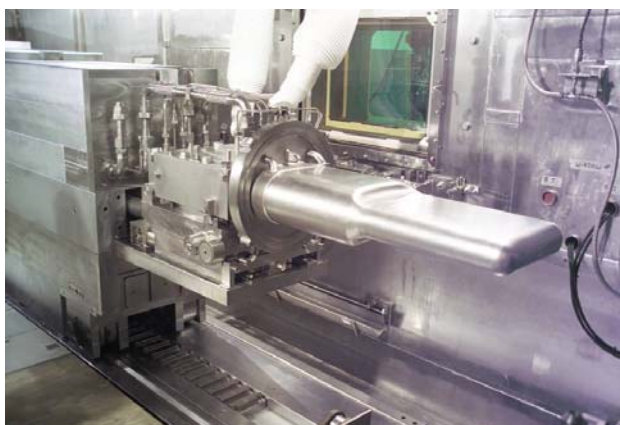
supply, coolant water supply, helium, vacuum, instrumentation and other utilities required for system operation. The Target Carriage also provides the means to move the target module into and out of the Core Vessel. Figure 1 depicts the target module mounted to forward end of the Target Carriage.

Figure 1: Target Module Installed onto Target Carriage

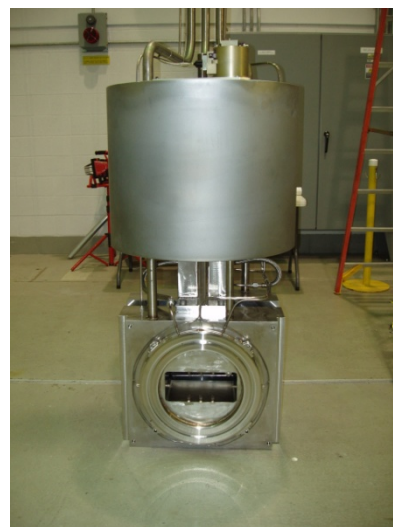
The first replacement of the Proton Beam Window (PBW) was successfully completed in August 2009 during the planned maintenance shutdown period. This initially-installed window had received just over 3000 megawatt-hours of accumulated energy resulting in an approximate dpa level of 6.5. The new PBW incorporated the optics portion of the Target Imaging System enabling viewing of the coated Target Module along with additional halo thermocouples to aid in beam centering. Following installation, Core Vessel and Ring to Target Beam Transfer (RTBT) flight tube vacuum leak testing indicated excellent PBW inflatable seal function. Figure 4 shows the new Proton Beam Window Module prior to installation.

Figure 4: Proton Beam Window Module

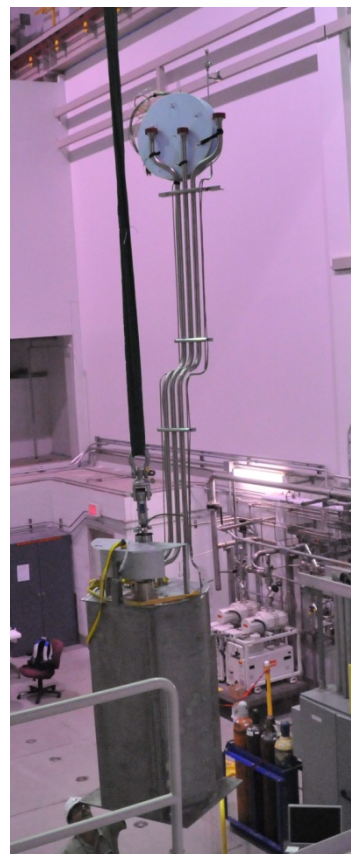
The installed location of the PBW requires relatively long utility piping (see Figure 5). Disposal of the PBW requires removal of this utility piping to reduce the overall package size for shipment. Removal of this utility piping during replacement operations therefore requires the use of a variety of long-handled cutting tools to sever the piping at the lowest point possible.

Figure 5: PBW Hoisted for Installation

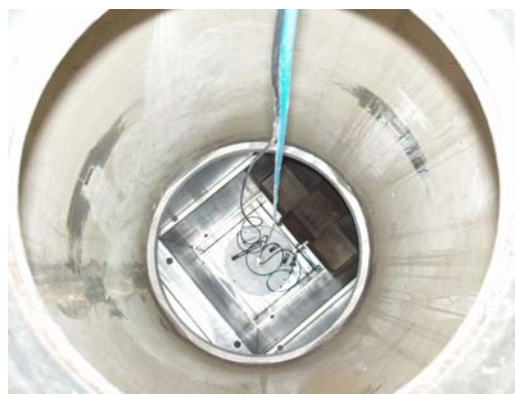
Since the helium line has already been severed along with the remainder of the utility piping in preparation for removal, a method of remotely attaching a vacuum line to this severed 3/8" line was devised. Following installation of this vacuum line onto the helium tubing, the seals can be retracted during removal of the PBW. Figure 6 shows the flexible vacuum line installed onto the severed tubing in preparation for PBW removal. During installation of the new PBW module, the process is simplified by simply applying a vacuum to inflatable seal helium supply line.

Figure 6: Flexible Vacuum Lines Installed onto PBW Module Prior to Removal

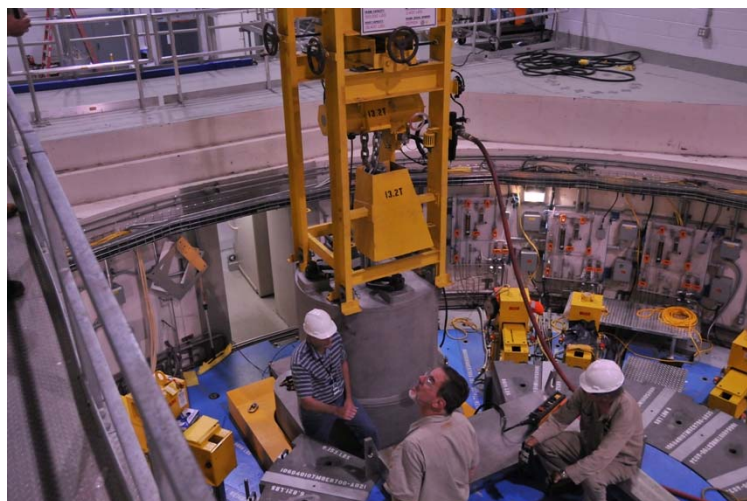
Figure 7 shows the PBW Cask in position over the cavity with the pneumatically-operated hoist (yellow structure) mounted to the cask. Following removal of the spent module, the cavity is inspected to ensure the sealing surfaces have not been damaged. This inspection is accomplished using a radiation-hardened camera mounted onto a long-handled tool. The tool provides tilt and pan capabilities for the camera with focus being controlled using the camera control box.

Figure 7: PBW Cask in Position for PBW Removal

Installation of the new PBW module is accomplished in essentially the reverse manner as removal. An installation Guide Can is utilized to ensure proper alignment and orientation of the PBW as it is positioned into the PBW Box.
