# Present status of JSNS and R&D for high power operation in J-PARC

**Abstract** In May 2008, the JSNS target accepted firstly the proton beams accelerated by LINAC and 3 GeV RCS (Rapid Cycling Synchrotron) accelerators at J-PARC. After that we have steadily increased in the power up to 220 kW for user operation. Just after the operation over 200 kW reached 1000 h approximately, the tremendous earthquake, Great East Japan Earthquake, hit us and forced to suspend the operation. Fortunately, the components consisting of the neutron source were not suffered with heavy damages, as compared with the accelerators. In the paper, the experiences up to 220 kW operation, including the damage due to the earthquake, and some R&Ds to reach 1 MW operation will be introduced; troubles and improvements in the supercritical hydrogen loop, the exchange of the mercury target vessel, the pressure wave mitigation system, proton beam flattening technique, observation of PIE specimen cut out from the target vessel, etc.

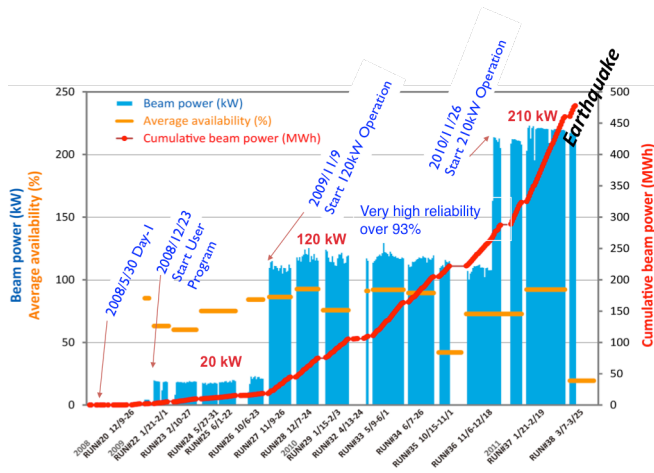
Figure 2 Proton beam power on JSNS target

In May 2008 the JSNS, whose structure and main components are seen in Fig.1 accepted firstly protons and yielded neutrons. After that the proton beam power was increased steadily up to 220 kW, as illustrated in Fig. 2. In the operation at 220 kW, the number of neutrons emitted from the coupled hydrogen moderator per unit solid angle per pulse was found to be  $3.8 \times 10^{12}$  [1]. As of 2010, the corresponding neutron intensities in the world's major spallation neutron sources were  $4.2 \times 10^{12}$  at the Spallation Neutron Source (SNS) facility in U.S.A., and  $4.0 \times 10^{12}$  at the ISIS facility in UK as shown in Fig.3 [1]. Thus it was confirmed that the neutron intensity achieved at J-PARC was almost comparable with those at the world's major pulsed spallation neutron sources. J-PARC's neutron intensity will eventually be three times higher than that of SNS when the beam power is raised to the rated 1 MW.

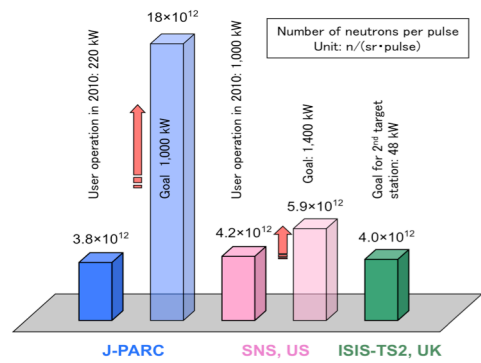
Figure 3 Comparison of neutron intensities of the world's major spallation neutron sources

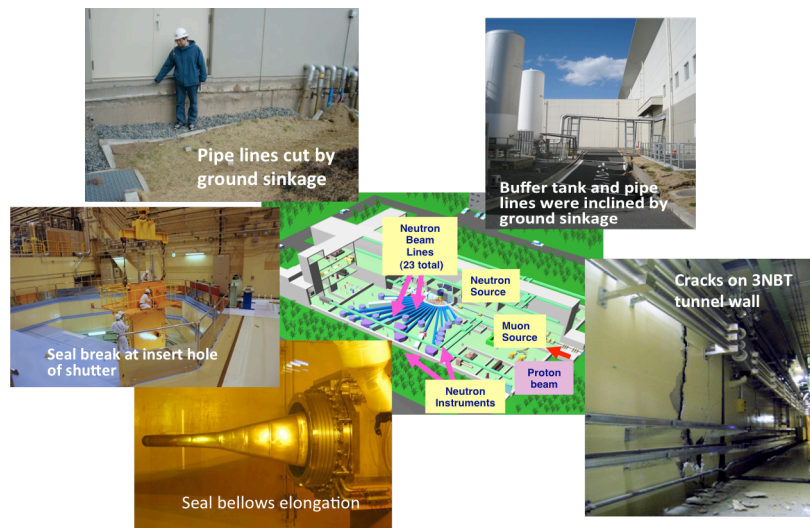
Figure 4 Damages around MLF: Subsidence with 1.5 m depth, inclination of liquid nitrogen tanks, cracks on the wall of 3NBT tunnel, broken shutter flanges, seal bellow elongation of target vessel, etc.

Damages around MLF (Materials and Life Science Experimental Facility) building induced by the earthquake were shown in Fig.4. Figure 5 shows the time-responses in main components at the earthquake; the first big quake occurred on 14:46, after about 30 min later the second quake on 15:16. The MLF building itself withstood the quake and suffered less damage. The damage to the mercury

circulation system, the remote handling systems and the coolant facilities in the building were limited and most of their components looked sound. One of the major damages in the neutron source components was a vacuum break of aluminum neutron beam ducts in neutron beam shutter blocks. Many bolts fastening a metal O-ring on a duct flange in more than half of the ducts were loosened because of an impact effect associated by a shutter movement and hitting the surrounding wall. All the 23 ducts were recovered in four months by taking countermeasure to prevent loosening of the bolts.

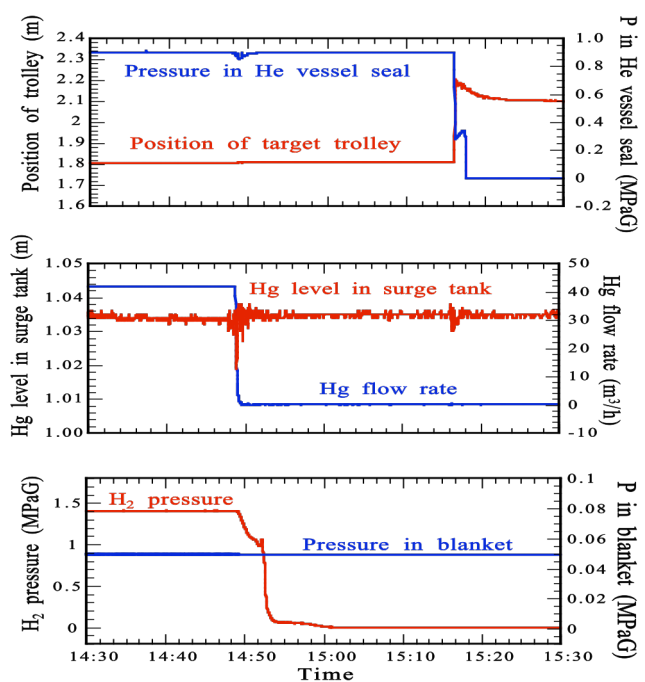
Figure 5 Time-responses in main components in MLF at the earthquake: He vessel pressure and position of target trolley; mercury flow rate and mercury level at a surge tank; hydrogen pressure and pressure in blanket.

When the earthquake occurred, the mercury circulation pump stopped and the flow rate decreased to 0 due to the power supply shutdown, but the total system kept soundness. The mercury level at the surge tank was fluctuated at the first and the second quakes respectively. The trolley movement influenced the helium vessel seal system installed on the target vessel. The helium vessel seal system pushes the seal onto the helium vessel flange by the pressurized helium gas in the metal bellows chamber. As the counteraction, the force to move the target trolley away from the system operation position is generated, but the trolley stopper actuated by compressed air supplied to the air cylinder prohibits the target trolley from moving. Due to the ground sink around the MLF building, the pipeline of compressed air supply was broken and the trolley stopper lost its actuation force. This trouble, along with the strong seismic shaking, resulted in the release of the trolley stopper. The target trolley lost its constraint force and the bellows of the helium vessel seal system extended too much and ruptured with a crack. The first target would not be used anymore.

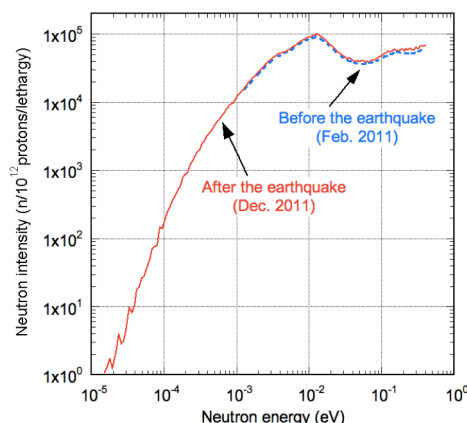
Figure 8 Neutron flux spectra before and after the earthquake.

On December 22, the first proton beam after the earthquake was successfully delivered to the mercury target in MLF. On December 23, a neutron beam was introduced for the first time to the NOBORU instrument (BL10) under 1 Hz operation. A neutron beam profile was measured with an image plate, as shown in Fig 7. Neutron flux intensity was measured with the gold foil activation method. A neutron TOF spectrum was measured with a He-3 monitor counter, seen in Fig. 8. It was confirmed through these measurements that the earthquake did not affect meaningfully the neutron beam characteristics.

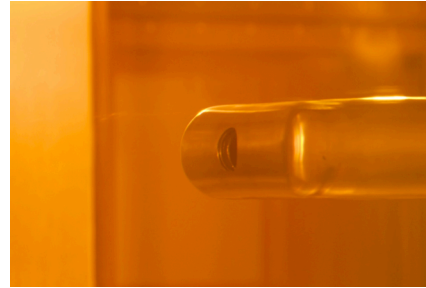
Figure 9 Disk specimen with ca. 5 cm in diameter cut out from the beam window of the target vessel

In advance to the target vessel replacement, disk specimens were cut out from the beam window of the target vessel. Using the cutting machine specially developed for this purpose, three specimens were cut out by remote-handling. The dose rate at the surface of the target vessel was more than 10 Sv/h, which is beyond the measurable range in a used device. The specimens were cleaned in an ultrasonic cleaner and the surface appearance of the innermost specimen which is the wall of the mercury vessel was observed as shown in Fig. 9. There were pitting damage clusters at the center and the both sides of it. Many spots of pitting damages were also scattered all around the specimen. The depths of these damages were measured by getting the replicas of the specimen surface : i.e. silicon rubber was put on the specimen to transcribe the surface shape onto the rubber and it was measured by the laser microscope. Submicron order of damage depth can be measured by this technique. The maximum depth of the damage found in the measurement so far was roughly 250  $\mu\text{m}$ , and there is a possibility that deeper damages which are not found yet. Further investigation of the specimens needs to be continued.

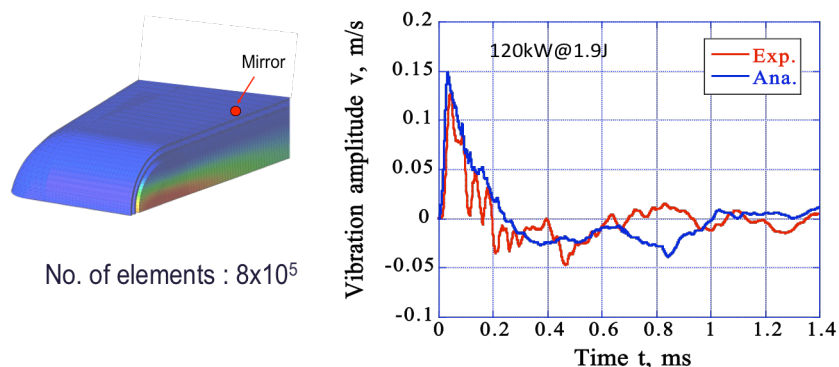
Figure 12 Comparison between experimental and numerical results on pressure wave response in mercury target vessel.

The diagnostic system was developed based on LVD (Laser Doppler Vibrometer) technique [5]. The laser path is formed through the clearance between moderator pipes and reflectors in the inner plug as illustrated in Fig.11. Fortunately the narrow path was not damaged by the earthquake. The mirror for laser beam equipped on the replaced target vessel improved to have a sufficient reflected intensity, which consists of micro-triangular-pyramids, which were machined precisely. Figure 12 shows the typical measured result of vibration responses to be compared with a numerical one. A good agreement was obtained to sufficiently verify the numerical model used for the design on target.
