Proceedings of International Collaboration on Advanced Neutron Sources (ICANS-VII), 1983 September 13-16
Atomic Energy of Canada Limited, Report AECL-8488

REMOTE HANDLING AT LAMPF*

D. L. Grisham and J. E. Lambert
Los Alamos National Laboratory
P. O. Box 1663, MS H840
Los Alamos, NM 87545

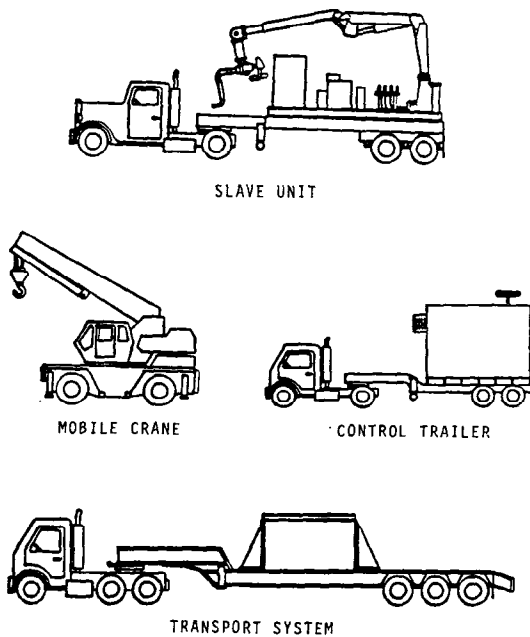
Fig. 6. Monitor III

Monitors I and II have served well in maintaining existing experimental equipment within area "A"; however, Monitor III will be needed to accomplish planned major rebuilding of target cells A1 and A6, particularly from the standpoint of removal and disposal of radioactive structural components. Figure 6 is a sketch of the Monitor III system. In addition to maintenance and construction, Monitor III will be used in transport and disposal of radioactive materials removed from the facility.

Monitor III will be a totally portable system, with its own power generator, capable of operating at any location accessible by truck.
