Proceedings of International Collaboration on Advanced Neutron Sources (ICANS-VII), 1983 September 13-16
Atomic Energy of Canada Limited, Report AECL-8488

OPERATING EXPERIENCE WITH THE IPNS NEUTRON GENERATING SYSTEM

A. W. Schulke, D. E. Bohringer, B. S. Brown, J. M. Carpenter

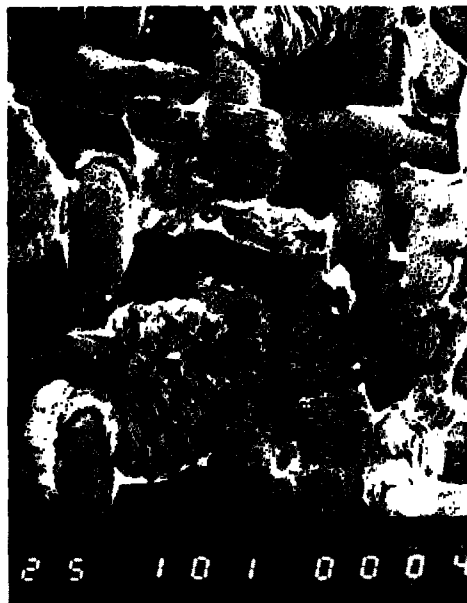
This photo is a magnification (70X) focusing on large particles in the upper right quadrant. Light colored regions indicate a non-conductive material.

After another attempt at operating the system we decided the problem was the plugging of the 15 micron filters which were located in the weld-sealed, evacuated heat exchanger box. These filters were removed and replaced by 90 micron filters. The new filters were relocated in an accessible part of the system and fitted with easily removed slip couplings. Proton beam was again delivered to the system and flows to the 4 liquid methane moderators at 100 K were much improved. Prior to this run, we also changed the 90 micron filters to assure ourselves that we had cleaned the foreign residue from the system (see picture). Samples of the methane gas were also taken again.
